# Manhole Inspection Summary

Manhole # S21II1016MH

Insp Date: **11/22/06 10:59 AM**

**Location** Address: **4282 CLYDESDALE AVE**

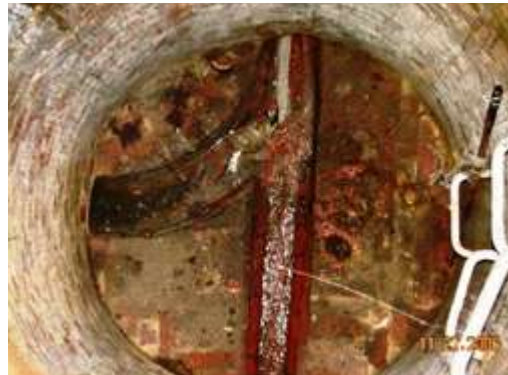
Top View

Evidence of surcharge - Bench debris.  
Channel debris.

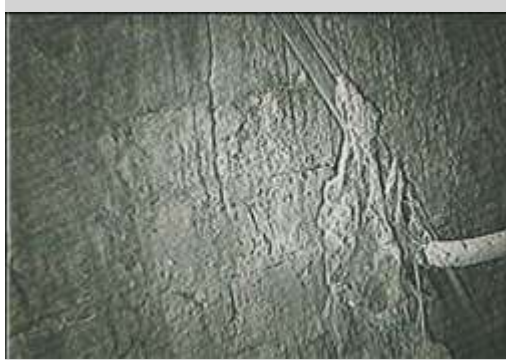
Evidence of surcharge

☒ **Evidence Of Surcharge** Depth: **2** (ft.) ☐ Active Surcharge Present

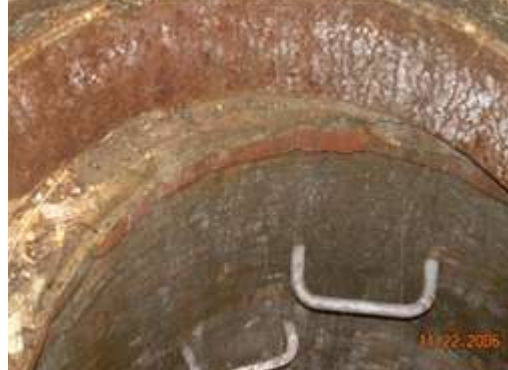
Defect

Condition: ☐ Sound ☐ Cracked ☐ Root Intrusion ☐ Loose Brick ☒ **Deteriorated**

Infiltration: ☐ None ☒ **Joint** ☐ Cracks ☒ **Mortar** ☐ Roots ☐ Wall

Infiltration: ☐ None ☐ Joint ☐ Cracks ☒ **Mortar** ☐ Roots ☒ **Wall**

Frame offset. Adjustment deterioration  
and infiltration. Corbel infiltration.
